## Complex diagnostics of concrete lining technical condition

To cite this article: Serhii Skipochka *et al* 2023 *IOP Conf. Ser.: Earth Environ. Sci.* **1156** 012002

Serhii Skipochka<sup>1</sup>, Viktor Serhiienko<sup>1,3</sup>, Volodymyr Amelin<sup>1</sup> and Larysa Amelina<sup>2</sup>

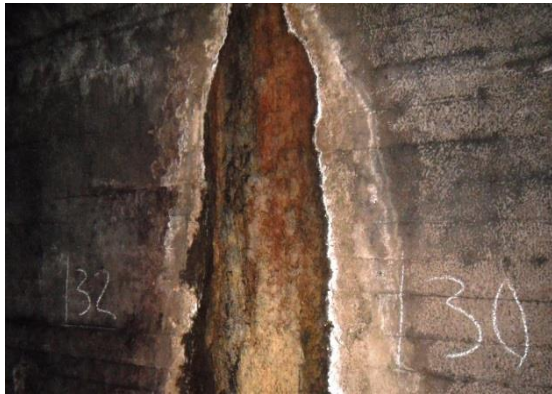
**Figure 1.** Water filtration through a destroyed juncture between sections of concrete lining.

The figures 1-6 depict the typical types of concrete lining defects.

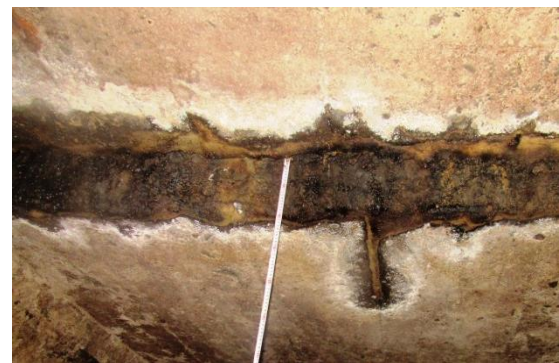
**Figure 4.** Vertical displacement of the concrete lining section.

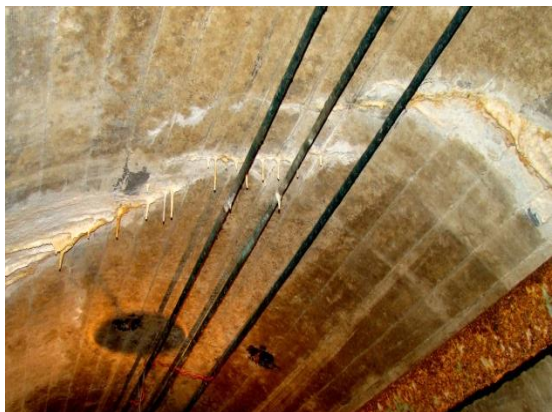
**Figure 5.** Cracks in concrete lining.

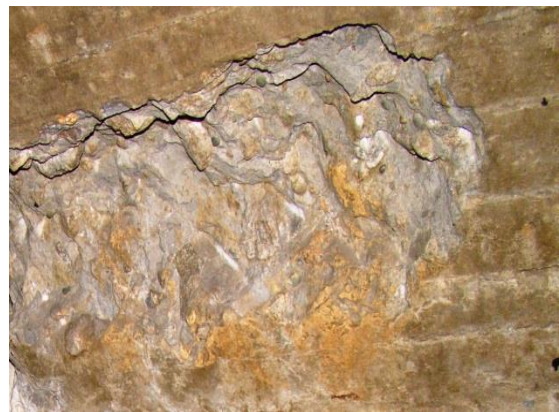
**Figure 6.** Concrete surface destruction.

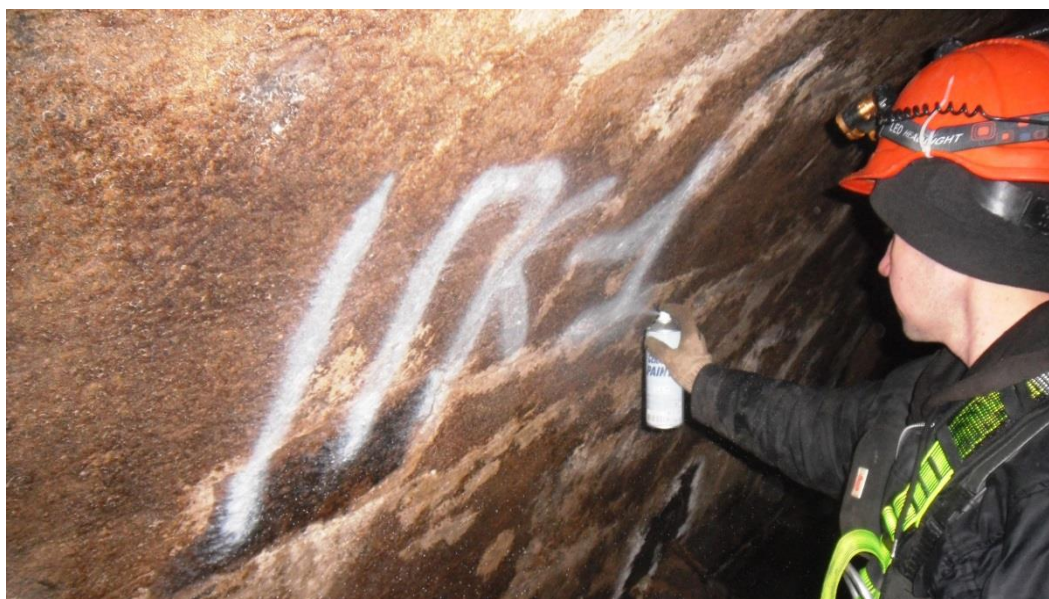
The main element of complex technical diagnostics is a visual examination. It is performed in several stages. The first step is to apply a dimensional grid to the surface of the lining. Usually its step is 2 m. In some cases, the step is reduced to 1 m. The best way is to mark the nodes of the grid with aerosol paint. If the concrete surface is dry and flat, you can use chalk. Figure 7 illustrates the marking procedure.

**Figure 7.** Marking performance on the concrete surface.

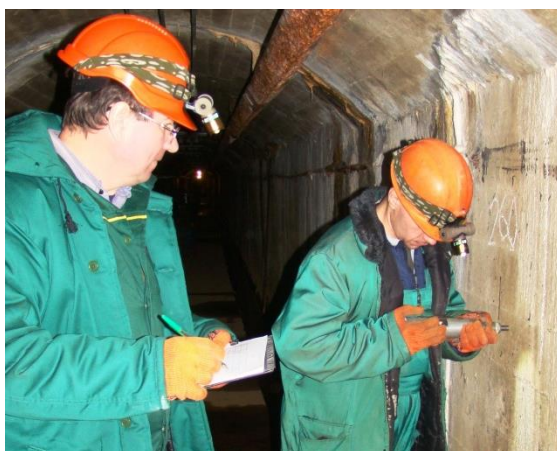
**Figure 8.** Strength of concrete determination with the elastic rebound method.

A mechanical sclerometer, such as *Schmidt Hammer 225*, is used for strength assessment with the elastic rebound method. The advantages of this method are high efficiency of control and the independence of the measurement results from the concrete composition. However, the elastic rebound method characterizes the concrete strength only at the control point. Due to the heterogeneity of the material structure, a significant variation of indicator of strength is observed.

As a rule, the strength of concrete determined with the ultrasound method is up to 20% higher than with the elastic rebound method. This is due to increase in the quality of concrete which is further away from its surface. If the results are more discrepant, the measurements are taken again in other control points. The process of strength of concrete determination with non-destructive testing methods is shown in figures 8 and 9.

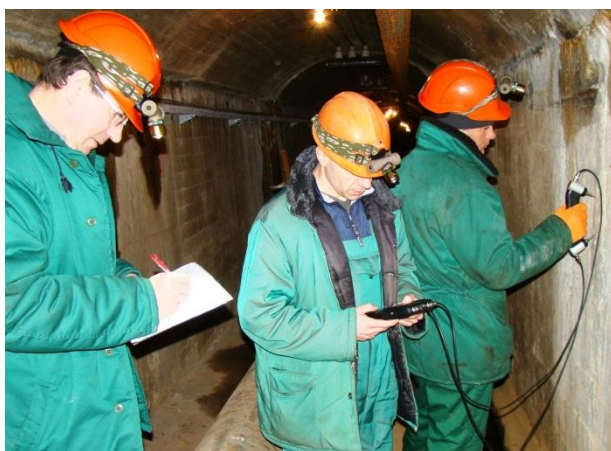
**Figure 9.** Strength of concrete determination with ultrasonic method.

*Novotest*, a Ukrainian-made device, was put to use to control the strength of concrete with the ultrasonic method. Its special feature is the availability of ultrasonic transducers with conical concentrators. It allows to take measurements without preliminary surface preparation. The result does not depend on the surface orientation. When applying ultrasonic control, the main problem is the need to predetermine the relation between the speed of the longitudinal wave and strength of specific types of concrete.

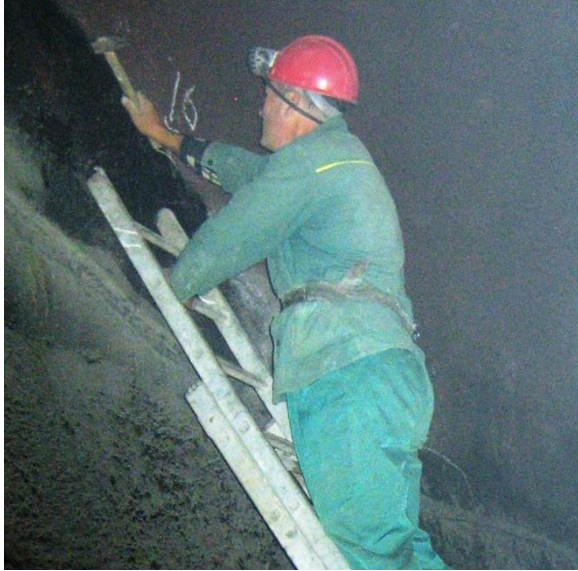
**Figure 11.** Excitation of vibrations in a concrete structure.

repair works, it is necessary to know their volume. For this purpose, selective control drilling is conducted in the center of the cavities. The depth of the cavity is measured with a probe. In most cases the cavity is filled with water. After the depth measurement is completed, the hole is tamped. Figures 11 and 12 illustrate the method of practical implementation of vibroacoustic diagnostics in a concrete water pipeline of a hydroelectric power plant.

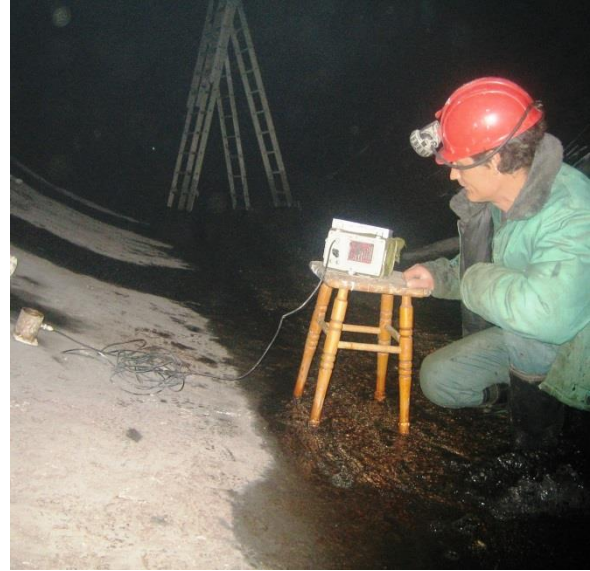
**Figure 12.** Distance registration of free oscillations of the structure.

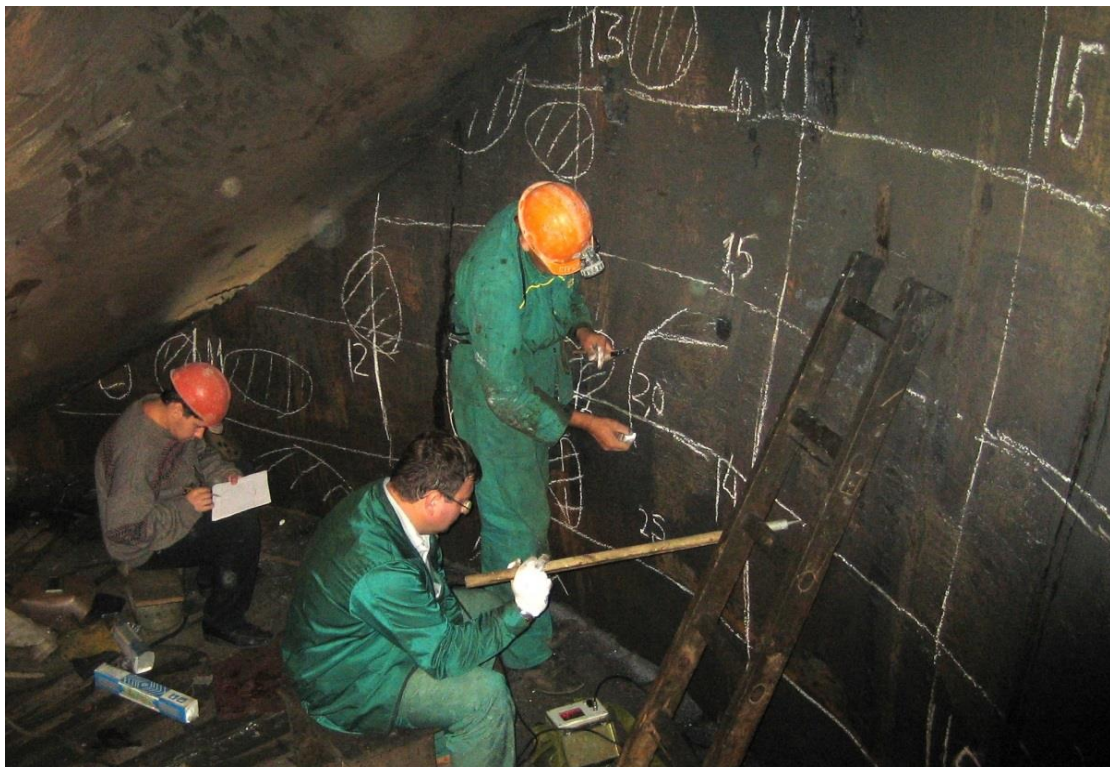
**Figure 13.** Selection of the contour of cavity on the results of vibroacoustic diagnostics.

Figure 13 illustrates the projection of cavities on the shell surface.
